REPORT OF THE INVESTIGATING COMMITTEE
CPP WASTE TANK WM-187 LEAKAGE
OF
MARCH 17, 1962

J. W. Latchum, et al

April 17, 1962

PHILLIPS
PETROLEUM
COMPANY

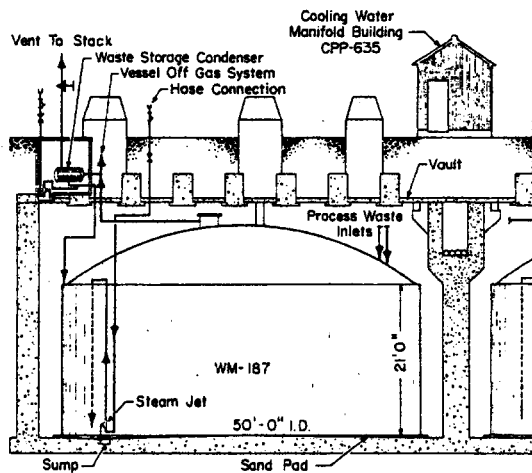
FLOW DIAGRAM WM-187

There are actually two sets of sump piping on WM-187, a typical 300,000 gallon first cycle waste tank, which could act as siphons. The purpose of each set is to transfer waste which may get into the vault back into the tank. A brief description of each system is as follows (Exhibit 2). A steam jet takes suction from a one-foot square by one-foot deep sump and discharges to the inside of the tank. The 2 inch schedule 80 pipe from the jet is routed up the outside of the tank wall thence through the tank roof and down the inside of the tank wall. The pipe terminates eight inches from the tank bottom.

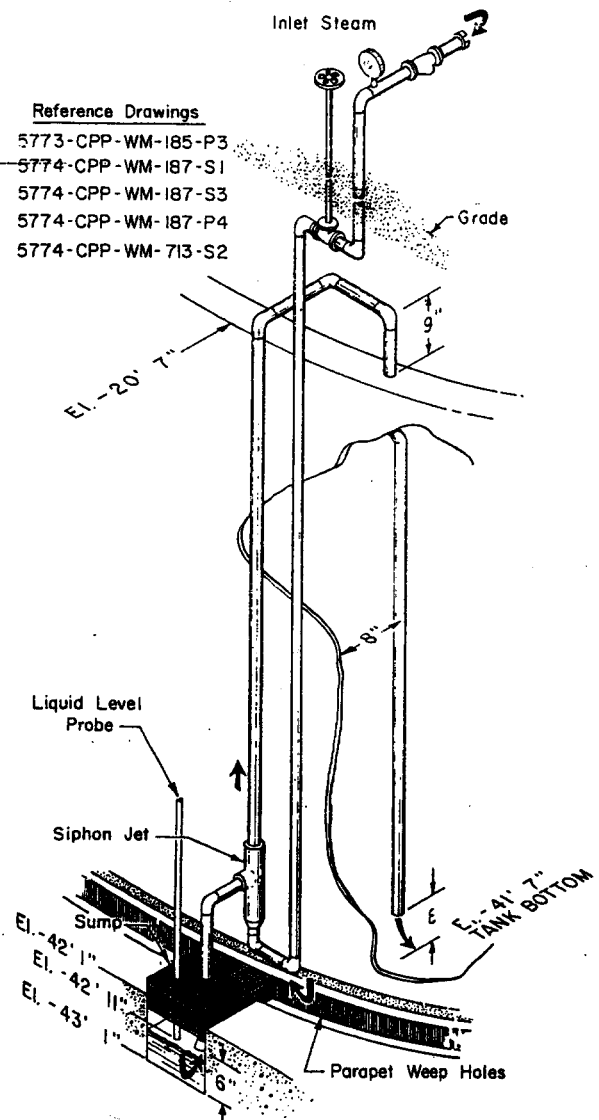
SUMP JET ISOMETRIC

2. The six most recently constructed storage tanks are equipped with jet siphon discharge lines which go down to within eight inches of the bottom of the tank. The jet discharge piping, which constitutes a siphon, is not equipped with a vacuum breaker in the case of WM-185 through WM-188, although tanks WM-182 through WM-184 may be, as it was requested after a field check review of the facilities by Phillips Petroleum Company. We do not know if these were installed. This original piping is poorly designed in that the dip leg must be vented through the steam supply line each time as soon as jetting is completed. As designed these jets are sensitive to maloperation.

With this piping arrangement on the jet discharge the probability of a syphon starting would depend upon the volume of liquid in the sump following the operating of a sump jet. Calculations showed 1.57 gallons of water was required to fill the jet discharge line before a syphon would start from WM-185; and assuming the same steam condensing rate per unit pipe area for the 1 1/2 inch steam supply line, the steam supply line would draw in approximately 5.95 gallons of water. The total water required in the south sump would then be 1.57 plus 5.95 or 7.52 gallons to cause syphon to start without venting the jet. The 12 x 12 x 12 inch sump holds 7.48 gallons when full.

(1) Provide a $\frac{1}{4}$ inch hole in the downcomer leg of the jet discharge line inside the tank above the high level line. A hole of this size could not pass enough air or vapor to cause a serious contamination incident.

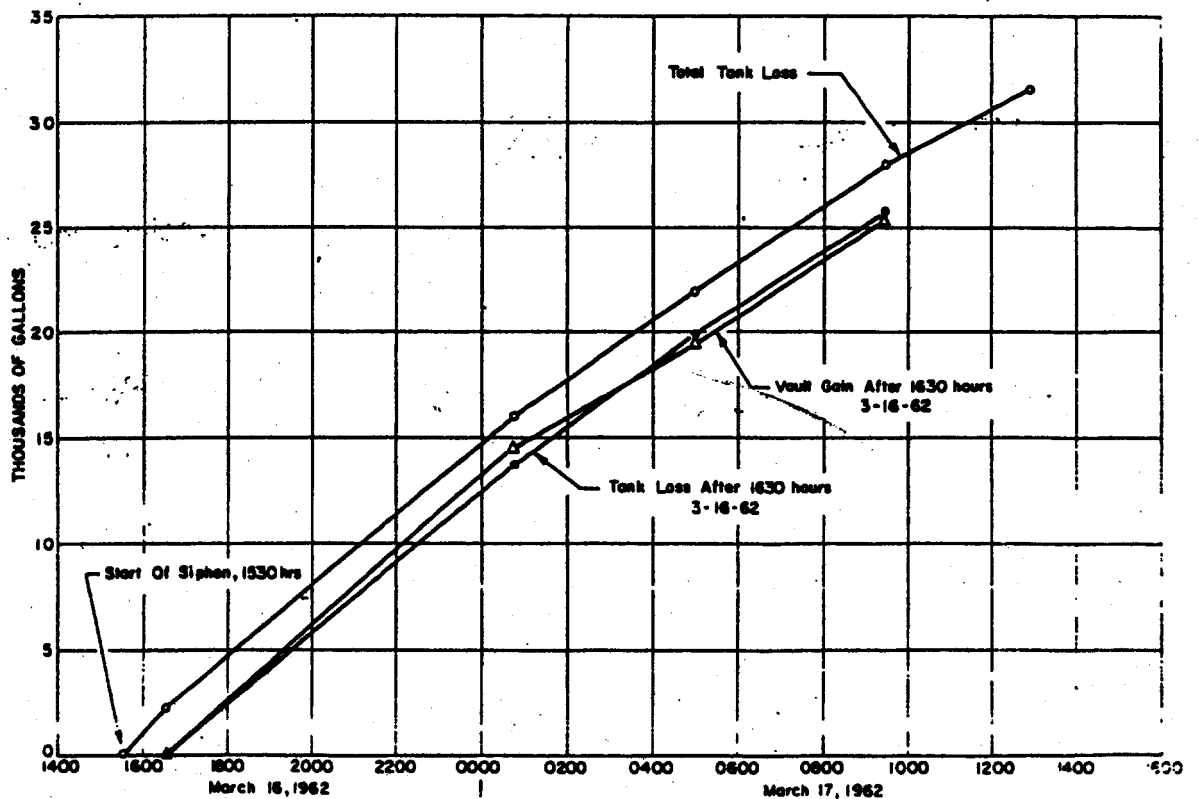
WM-187 Loss in Tank Contents
(& Comparative Tank Loss-Vault Gain)
During Siphon Period

Once the siphon was established it operated according to the energy balance stated by Bernoulli. The energy source was the difference in fluid head between tank interior and the vault. It can be shown from the data that equilibrium was not reached. Approximately 31,700 gallons were measured as leaving the tank which represents a level change in the tank of about 2 feet. The vault strapping is estimated at 730 gallons per inch. Not counting ground water in-leakage the vault level would have risen about 3½ feet above the vault floor. This is approximately 2½ feet of fluid short of equilibrium. An attempt was made to calculate the amount of the leak independently, using the head conditions at the start of the incident, that could be expected through one sump jet line on tank WM-187. It was calculated at 38,200 gallons over a period of twenty one and one half hours compared to the actual volume of 31,700 gallons during the same time period.
